February 23, 2014

Re: University Village Apartments Partial Walkway Collapse  
Structural Engineering Evaluation

University of Missouri  
 University Village Walkway Collapse  
 Columbia, Missouri

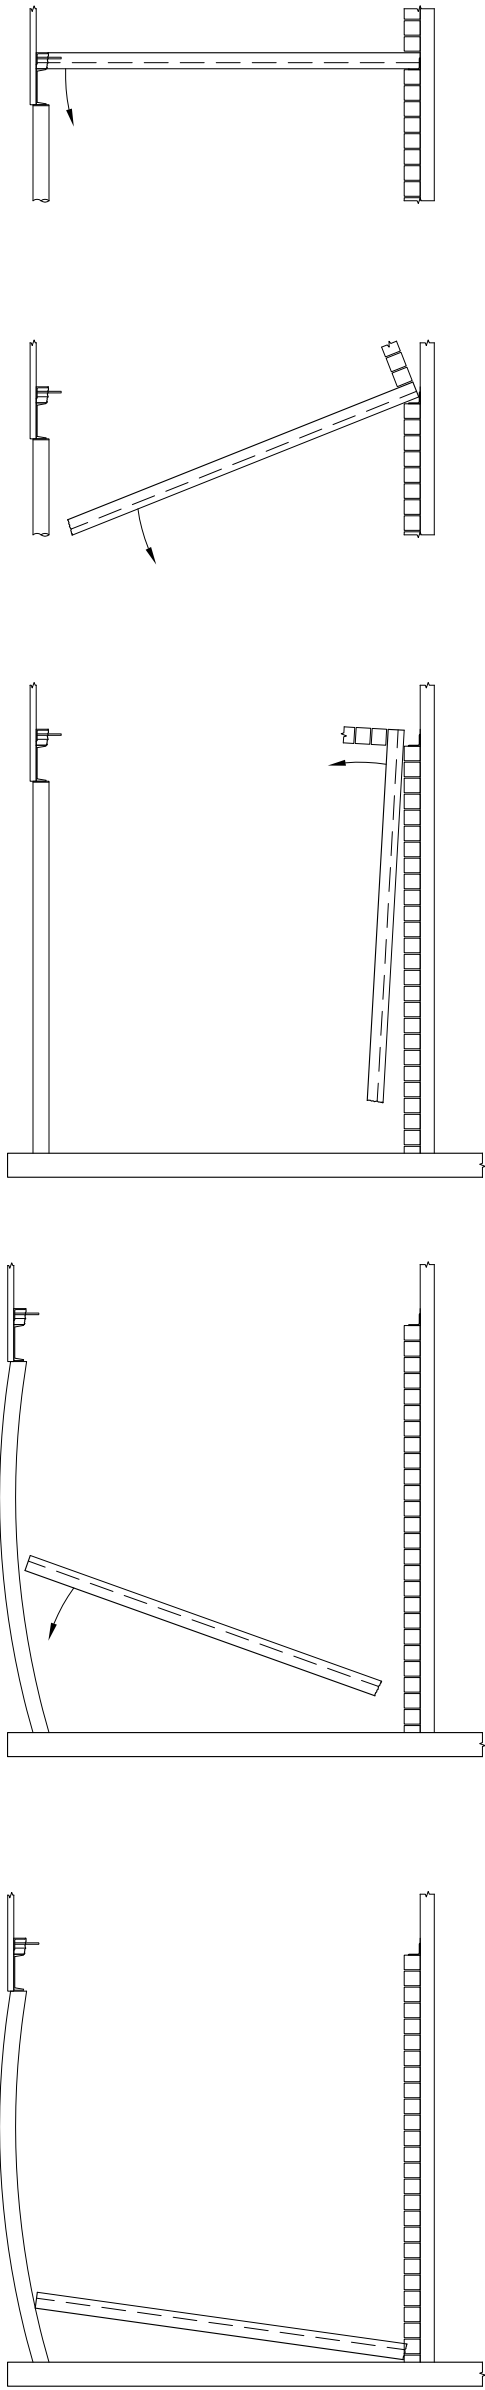
1 Assumed Schematic Walkway Failure Mode  
 SK1 1/4" = 1'-0"

A portion of the building 707 walkway at the east end had collapsed and was found to be resting, upside down on the walkway below. It is believed that the failure originated near the exterior channel support framing which then resulted in the loss of structural support for the elevated concrete walkway. See the attached sketch SK1 that represents the assumed failure mode & geometry of the incident.

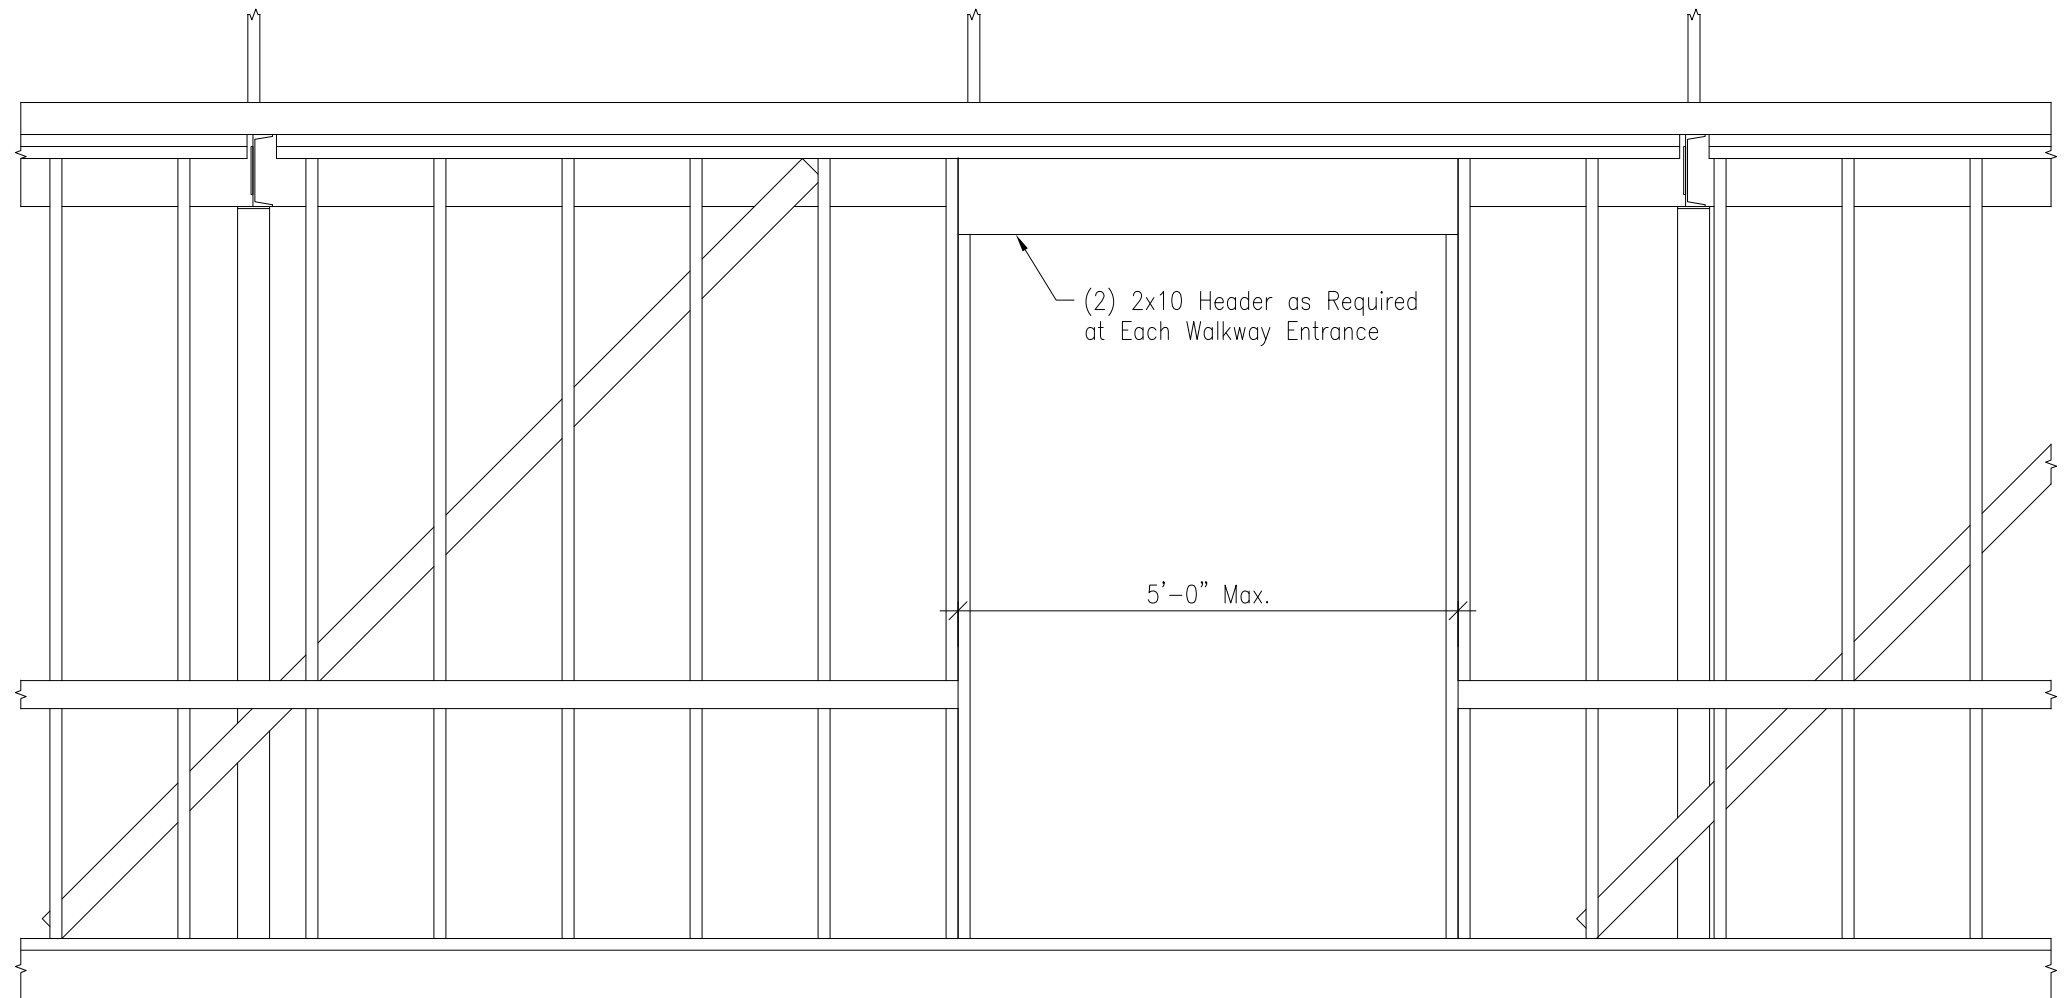
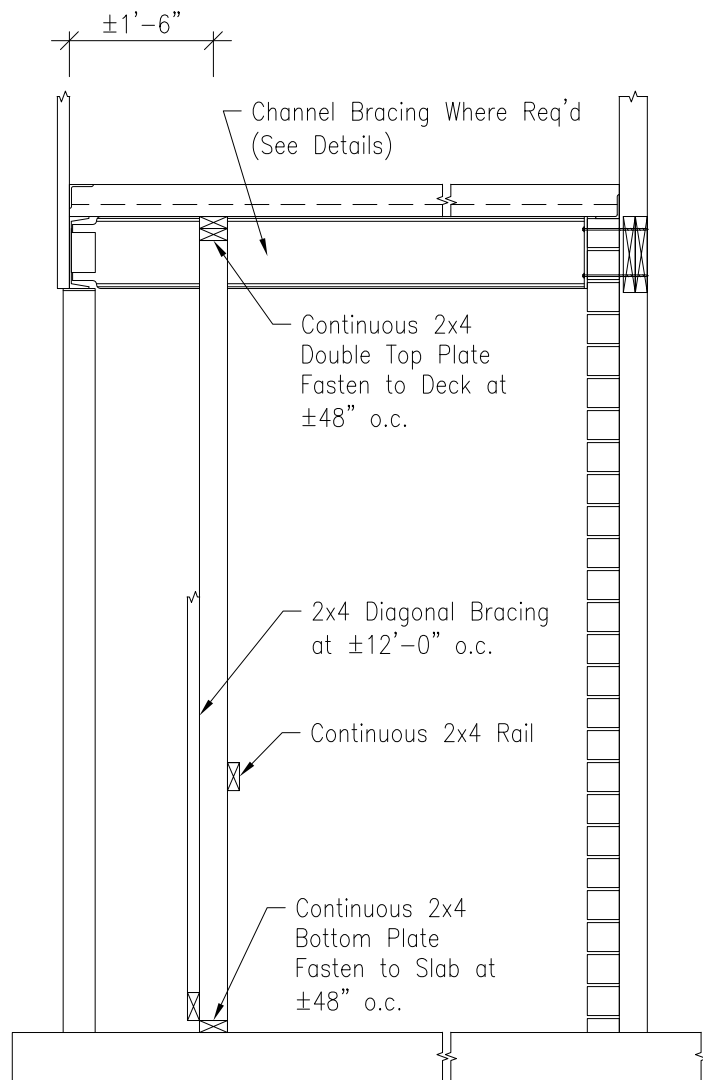
**1** Temporary Shoring  
SK2 1/2" = 1'-0"

In general the load-carrying capacity of at least portions of the walkway framing observed in this category was very questionable. Some areas of complete section loss of the steel and concrete deck were found and, unless remedial action is taken, a catastrophic collapse could be imminent. The wood shoring represented on sketch SK2 was installed immediately to allow for the continued occupation of the dwelling units. Additionally, the channel lateral bracing shown on SK2 is recommended to be installed relatively soon (i.e. within 6-weeks) to help prevent additional lateral and torsional movement of the exterior channel and supported guardrail.

In general the load-carrying capacity of at least portions of the walkway framing observed in this category was very questionable. The wood shoring represented on sketch SK2 was recommended to be installed as soon as possible to allow for the continued occupation of the dwelling units. Additionally, the channel lateral bracing shown on SK2 is recommended to be installed relatively soon (i.e. within 6-weeks) to help prevent additional lateral and torsional movement of the exterior channel and supported guardrail.

Once the assumed cause was identified *THHinc* developed a shoring system that would provide temporary support for the remaining portions of the walkway. The purpose of this framing was to prevent additional damage and to allow for escorted, short-term access into the dwelling units so that personal belongings could be retrieved. Reference sketch SK2. The interior of a second story unit was observed and, although no related damaged was noted, it was recommended that this building should not be occupied in its current condition.
